THE CENTRAL COUNCIL OF CHURCH
BELL RINGERS

Church Restoration & Alteration Projects

Considerations for Bell-Ringing & Bell Ringers

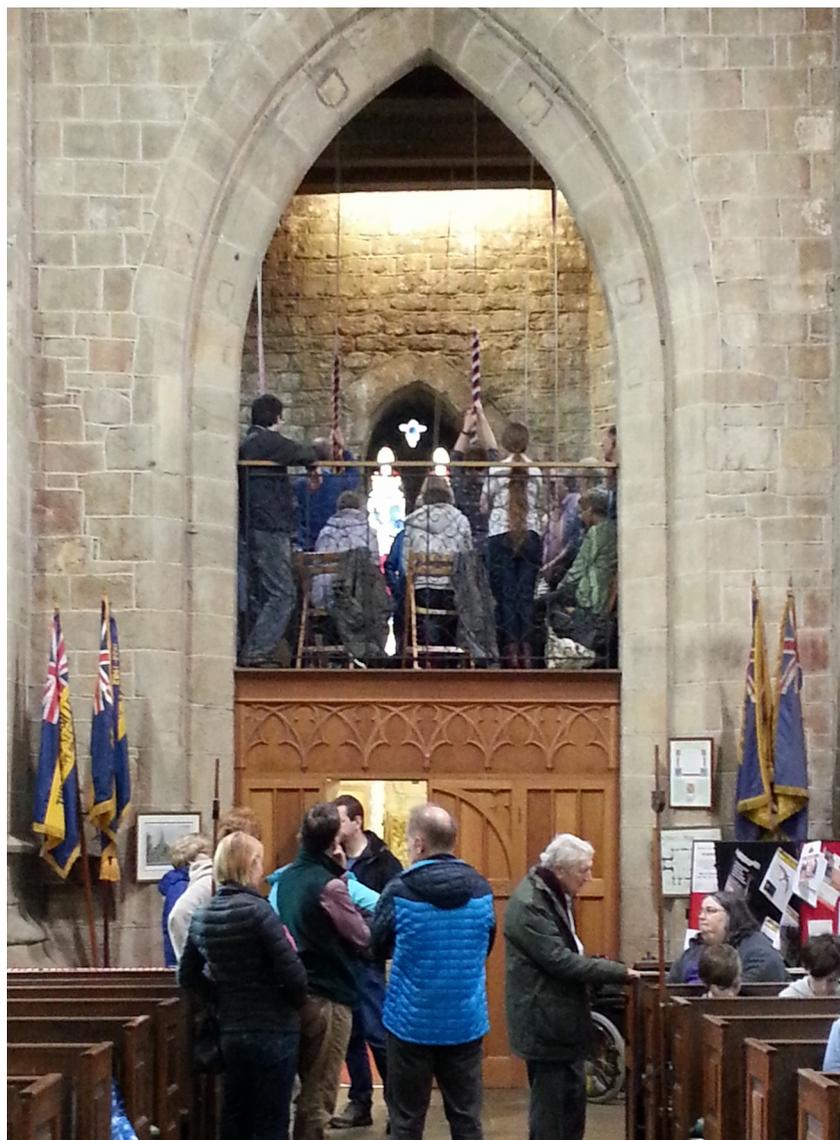
Open gallery style ringing room. This design offers useful enclosed space at ground level. (The addition of a glass screen or long openable curtains across the arch would enable the ringing room to be heated when necessary.)

Young people, in particular, will normally be fascinated when they see ringing underway (at a safe distance) so keeping or enabling the ringers to be visible is very helpful. This may be more straight forward if the ringing room is at ground level, or in an open gallery. Ringers who enter the tower from outside, go upstairs and are then invisible results in 'out of sight out of mind'. Having said this, a ringing room that is part of a large unheated space, may be rather inhospitable in winter for ringing practices! Architects are often able to design appropriate screens that enable the ringers to be visible but enclosed, with suitable ventilation.
